# Ludwigia Control Project

## Year Two Report

February 2007

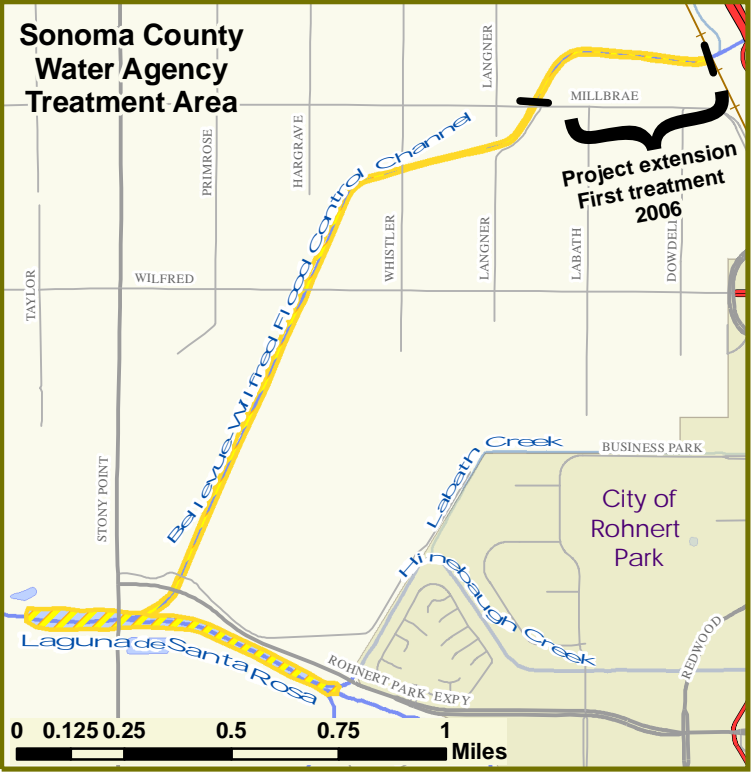
Figure 1

General Locator Map for Ludwigia Control Sites within the Laguna de Santa Rosa

Project locations were generally the same as in 2005, though each site was expanded slightly (Figure 1).

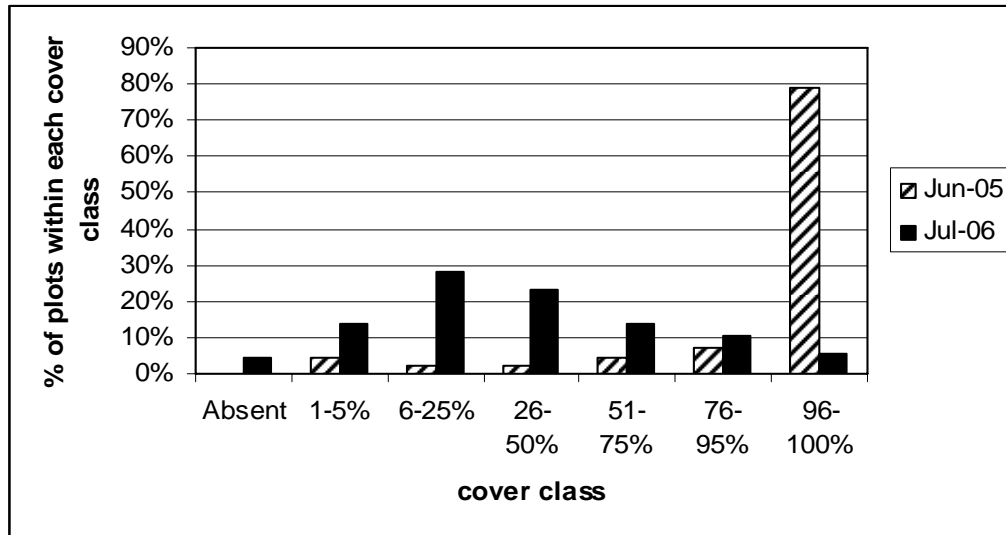
Figure 3. Frequency distribution of *Ludwigia* cover classes in the Laguna Wildlife Area flooded wetlands in 2005 (n=43 plots) and 2006 (n=107 plots). The graphs show a decline in density in 2006.

Figure 3 compares the distribution of *Ludwigia* cover classes in the flooded wetlands of the Laguna Wildlife Area in June 2005 and June 2006. The graphs represent a picture of the site before and after one season of glyphosate application and the associated impact of driving over the plants in the MarshMog. In June 2005, 80% of the 43 plots sampled fell within the 96-100% *Ludwigia* cover class. In June 2006 the same cover class was represented in only 6% of the 107 plots sampled while the largest percentage of plots (28%) fell within the 6-25% cover class. Notably, *Ludwigia* still occurred in 95% of all plots sampled in 2006 suggesting that the density of *Ludwigia* was significantly reduced but the overall distribution remained largely unchanged.

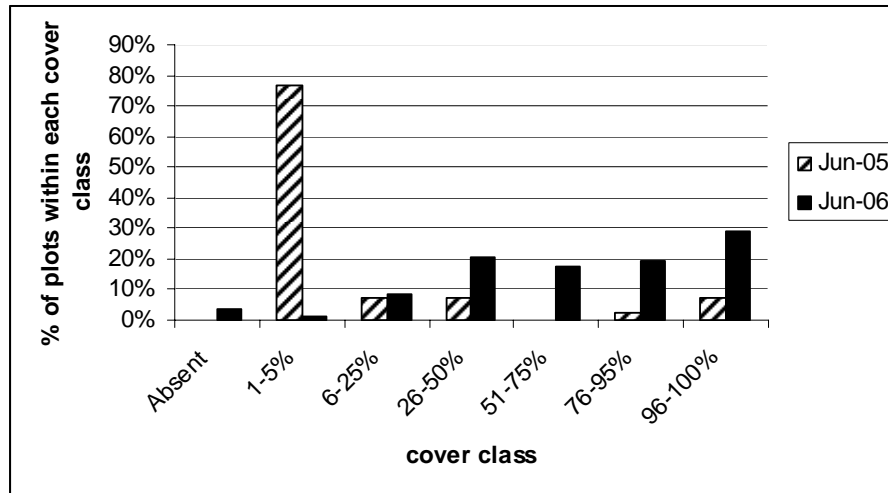
Figure 4. Frequency distribution of open water cover classes within the Laguna Wildlife Area flooded wetlands, June 2005 and June 2006.

The cover of open water also increased between years (Figure 4). In June 2005, 77% of the 43 plots had between 1-5% open water. In 2006 the trend shifted toward more open water with 87% of 107 plots having greater than 25% open water, 66% having greater than 50% open water, 49% having greater than 75% open water and 29% having greater than 95% open water. This is despite a measured drop in water level from the same period in 2005 (average water level 10 cm lower, mode water level 20 cm lower). This further suggests that the density and stature of *Ludwigia* was reduced.

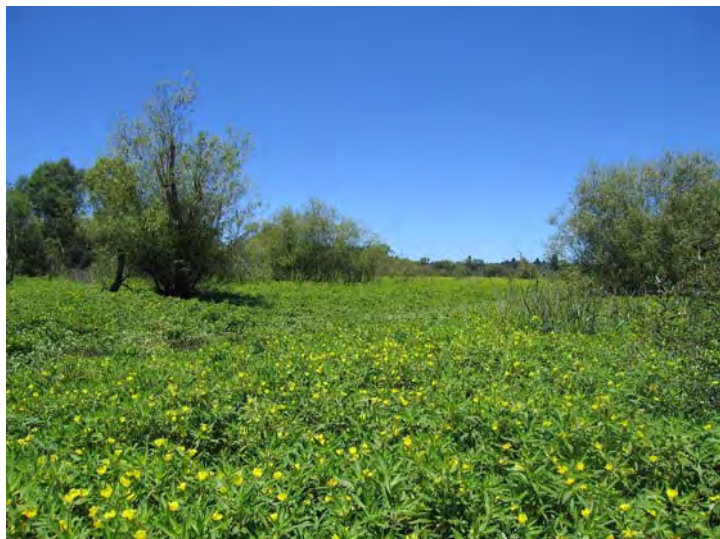
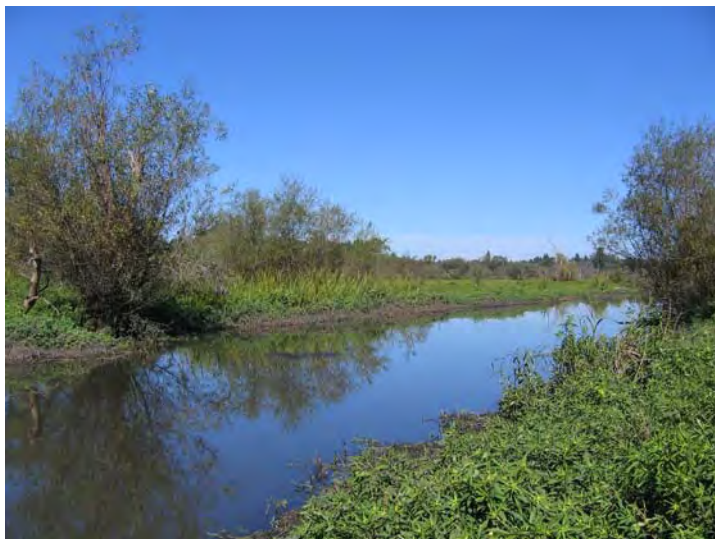
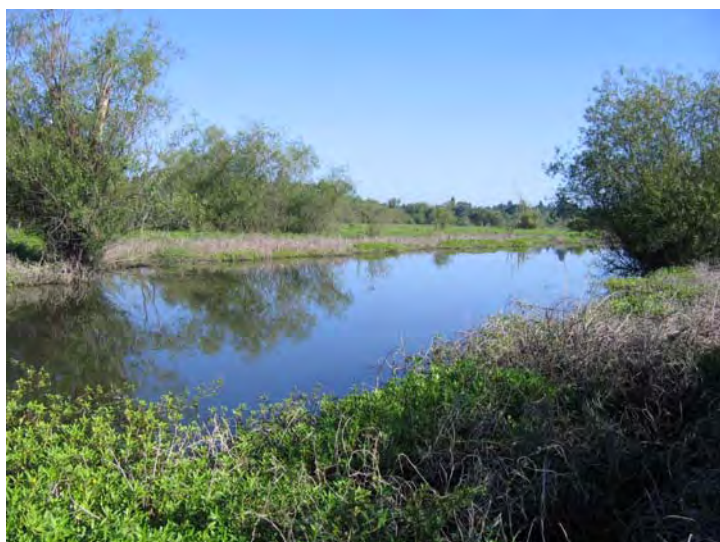
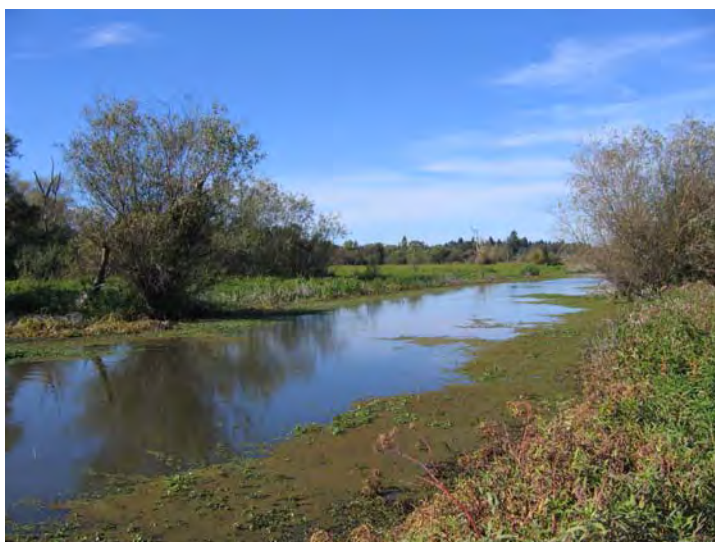
**Figure A1. CDFG Laguna Wildlife Area: Photo Point A-01**

Series of Laguna channel just north of the flooded wetlands of the Laguna Wildlife Area. The channel remained open between years with some regrowth evident in June and October 2006. The darker green in the channel in the October 2006 photo is water fern (*Azolla filliculoides*). The herbicide application in 2006 included initial treatment with glyphosate and touch-up with triclopyr.

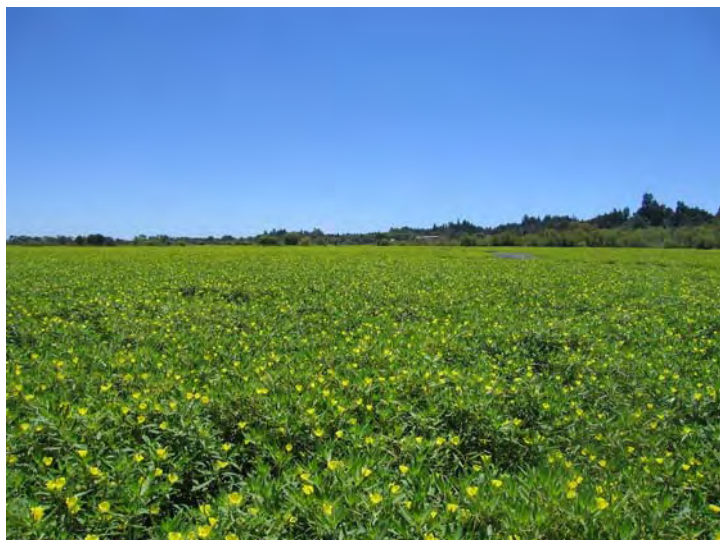
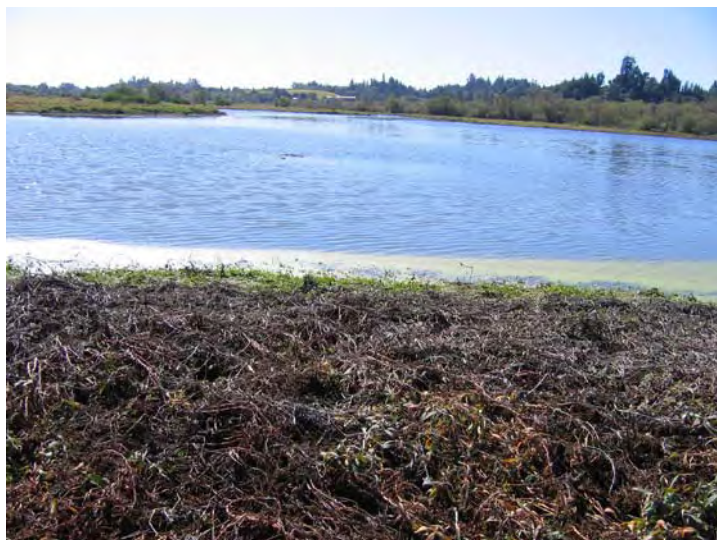
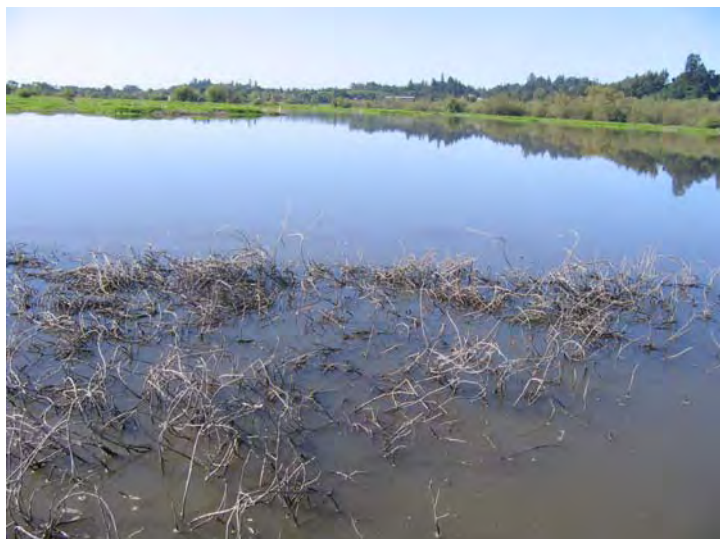
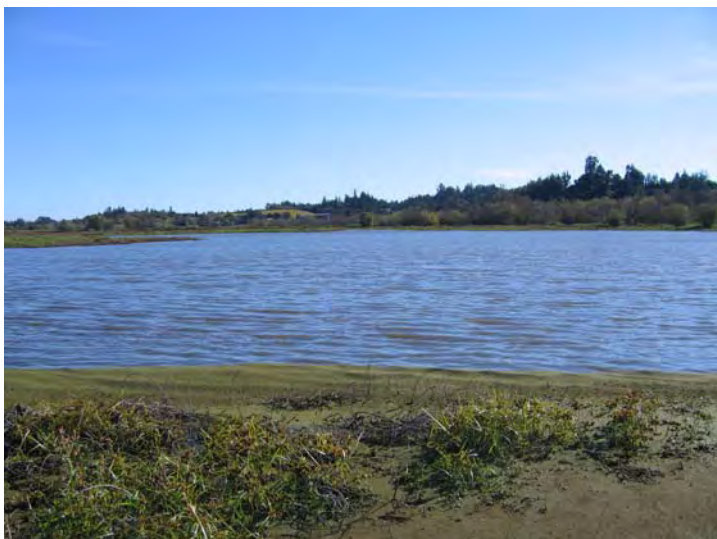
**Figure A2. CDFG Laguna Wildlife Area: Photo Point B-05**

North field, flooded wetlands in the Laguna Wildlife Area. This shows the only large area within the fields where biomass could be removed; access prohibited removal elsewhere. Removal was not necessary in 2006 because of minimal regrowth. The edges were sprayed with triclopyr in 2006.

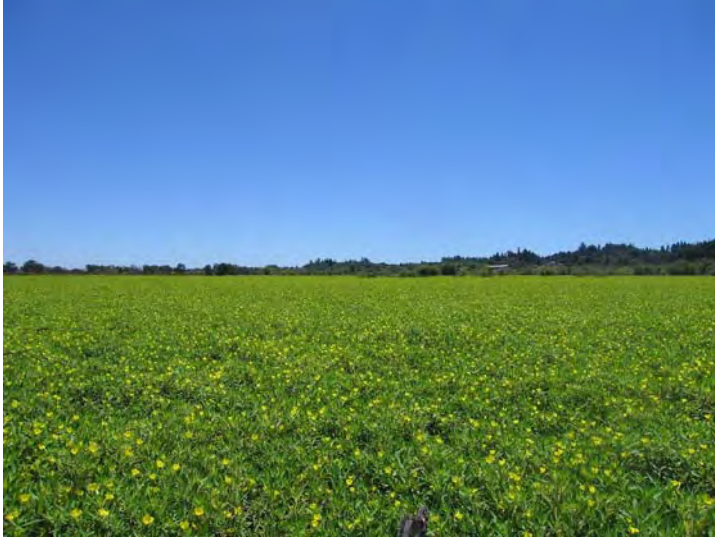
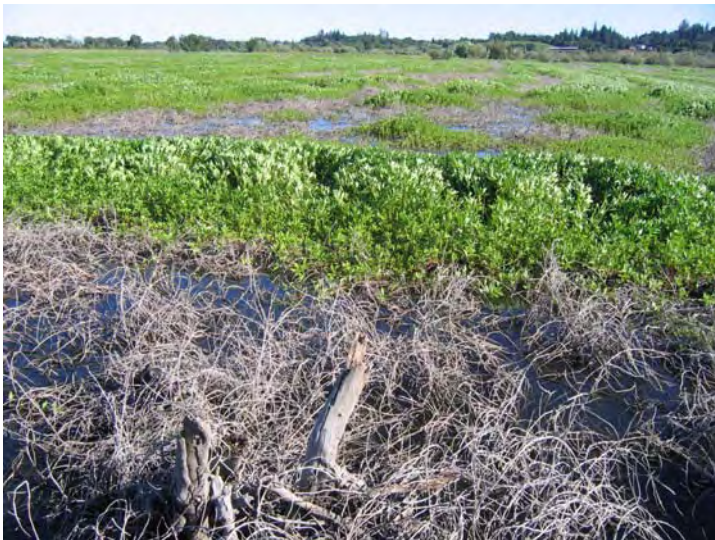
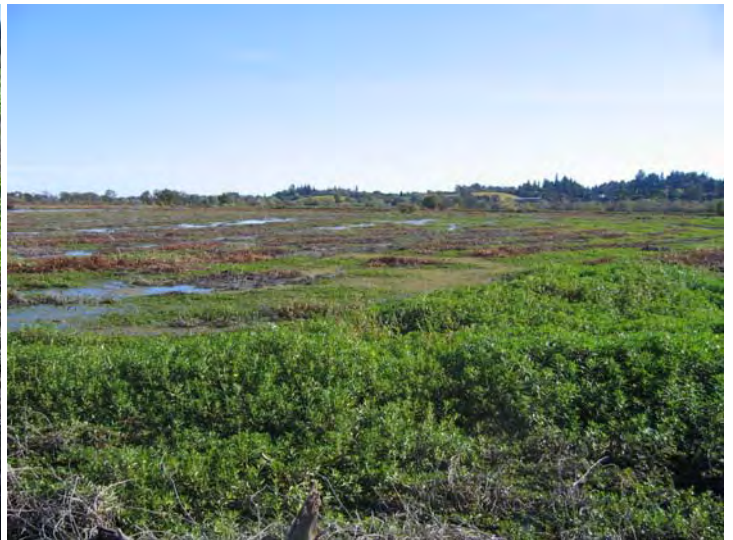
**Figure A3. CDFG Laguna Wildlife Area: Photo Point C-11**

North field, flooded wetlands in the Laguna Wildlife Area. This area was sprayed with glyphosate in 2005 and triclopyr in 2006. No biomass removal occurred.

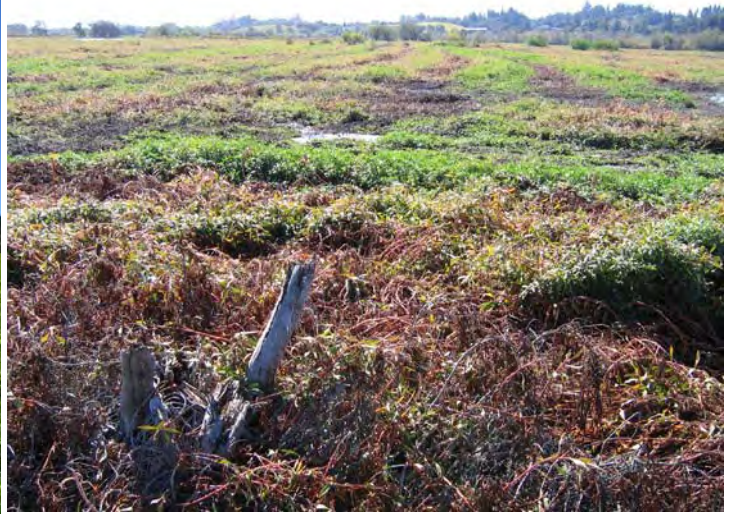
Post-removal  
October 2005

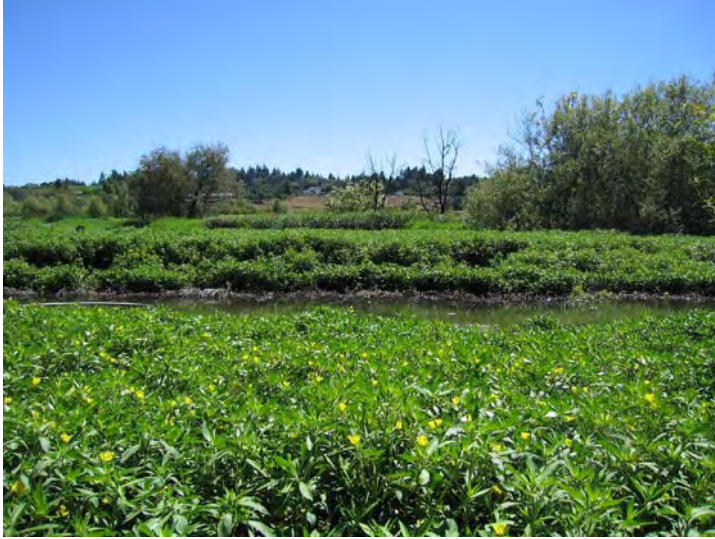
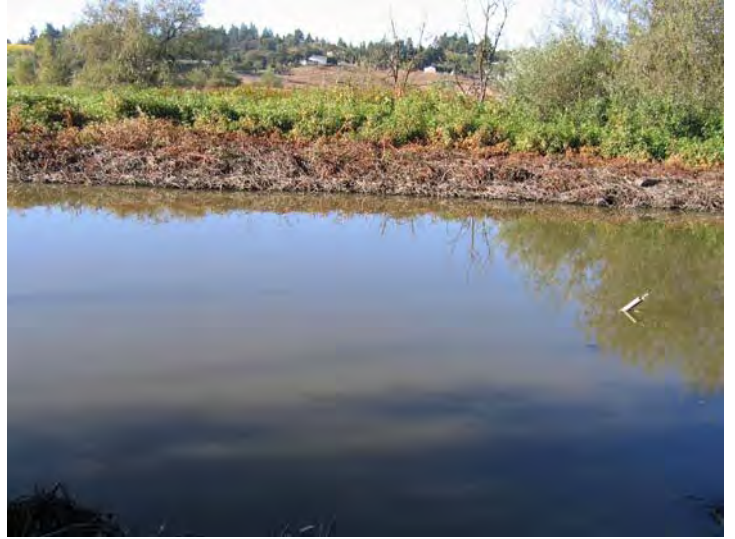
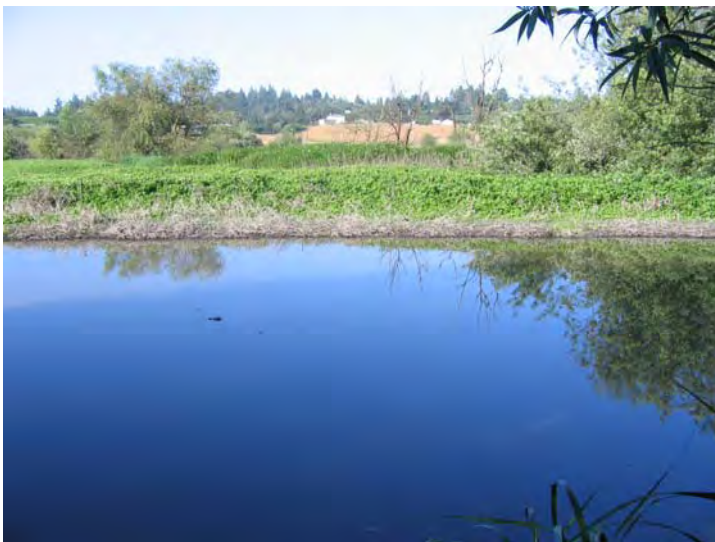
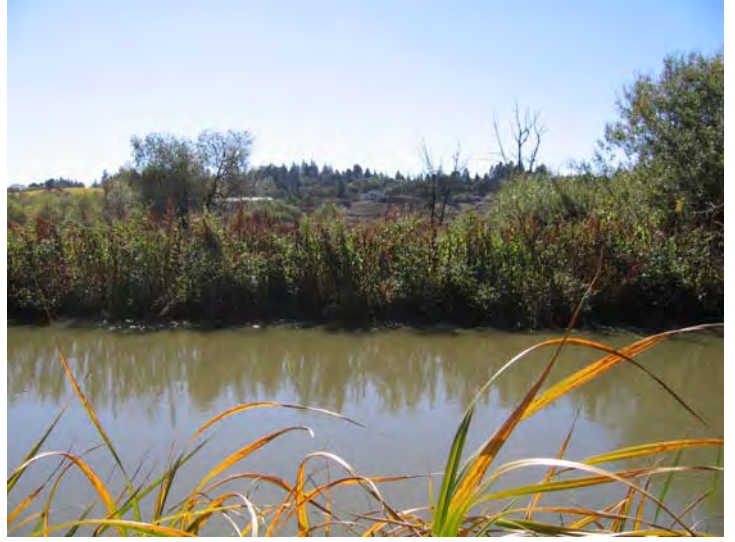
**Figure A4. CDFG Laguna Wildlife Area: Photo Point H-26**

Series of channel in Laguna Wildlife Area. This area was treated with glyphosate in 2005. The initial 2006 application was with glyphosate and touch-up with triclopyr. Note the growth of non-Ludwigia species on the far bank in October 2006 compared with July 2006 when Ludwigia dominated the bank. Minimal regrowth after 2005 precluded need for removal in 2006.

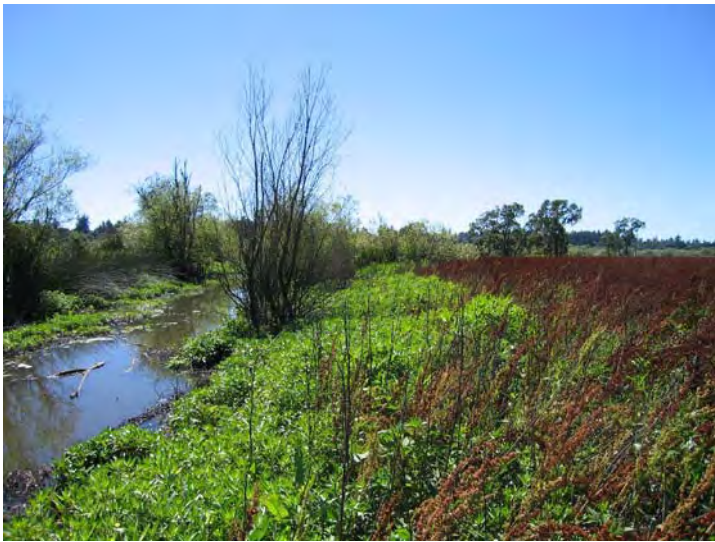
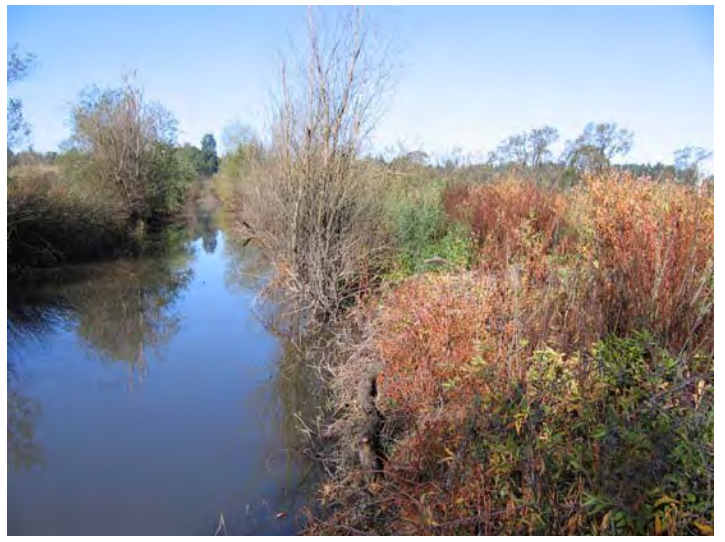
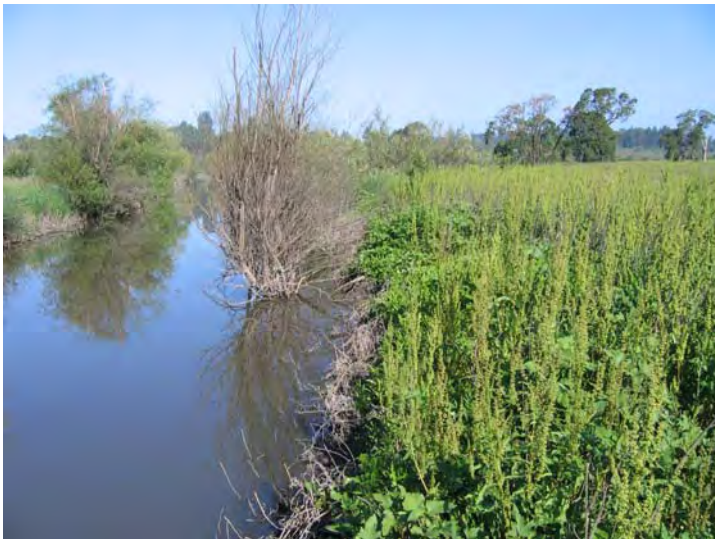
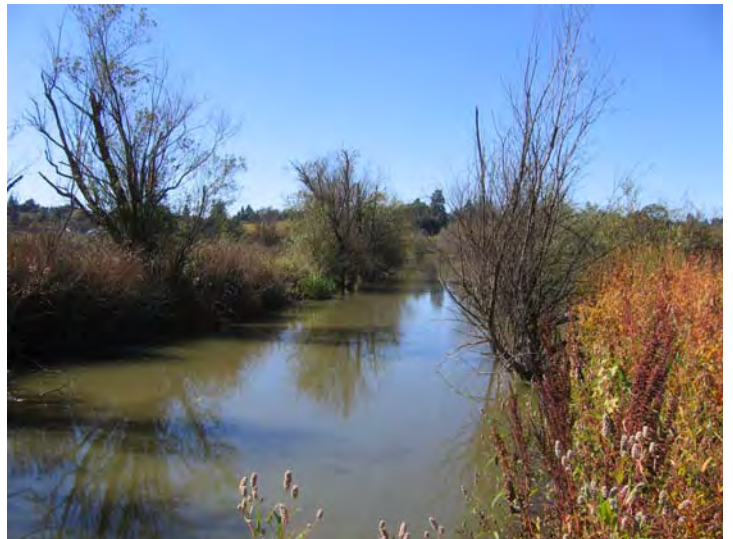
**Figure A5. DFG Laguna Wildlife Area: Photo Point K-35**

Another series of channel in Laguna Wildlife Area also treated with glyphosate in 2005. The initial 2006 application was with glyphosate and touch-up with triclopyr. Negligible regrowth in 2006.

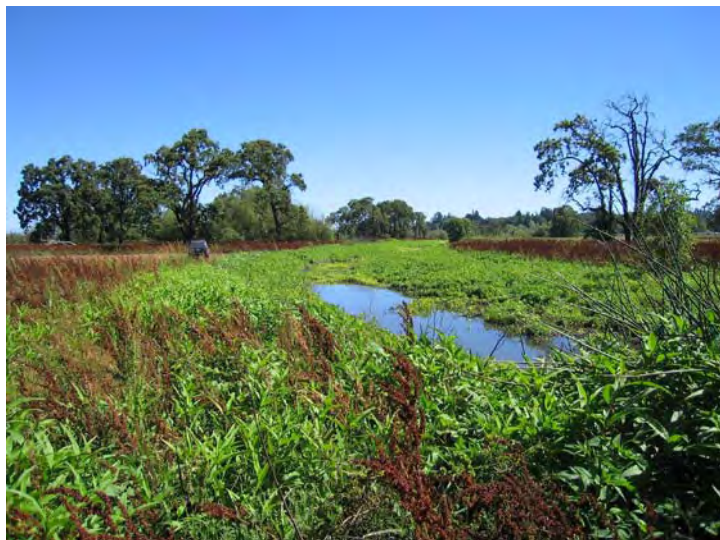
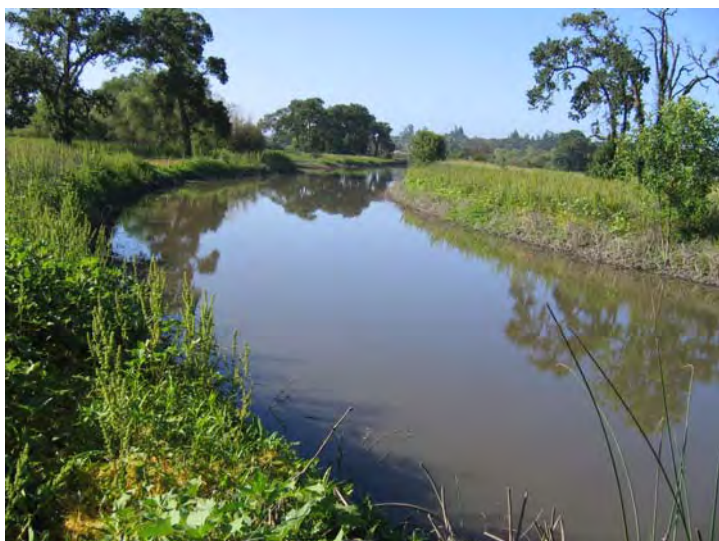
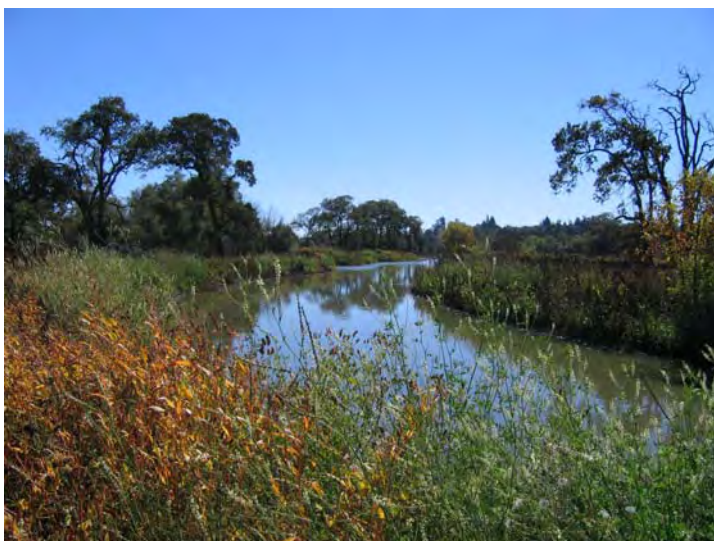
**Figure A6. CDFG Laguna Wildlife Area: Photo Point L-38**

Final series of channel in Laguna Wildlife Area. This area was treated with glyphosate in 2005. The initial 2006 application was with glyphosate and touch-up with triclopyr. Minimal regrowth after 2005 precluded need for removal in 2006.

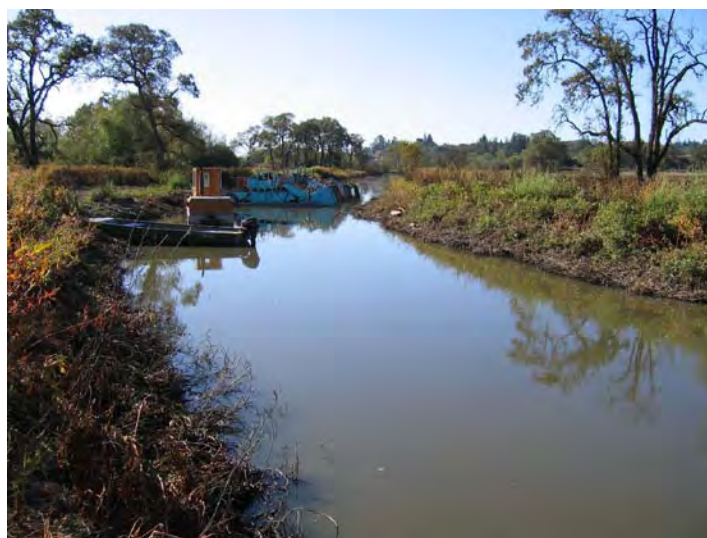
Post-removal  
October 2005

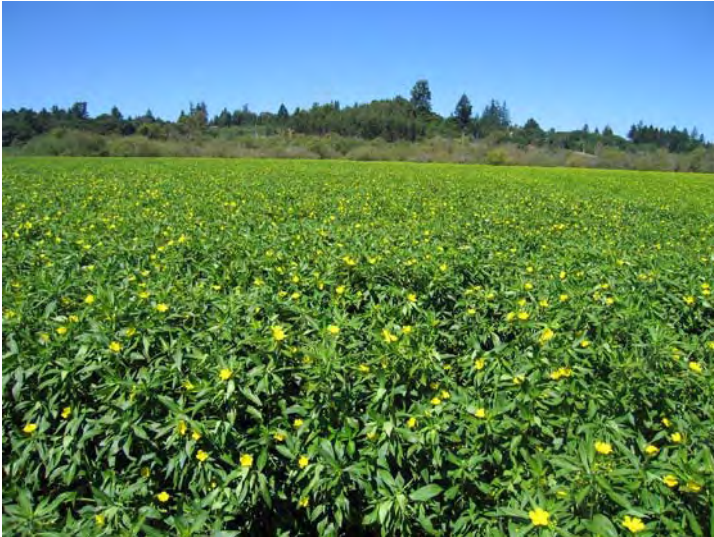
**Figure A7. CDFG Laguna Wildlife Area: Photo Point Q-46**

Pre-spray  
July 2005

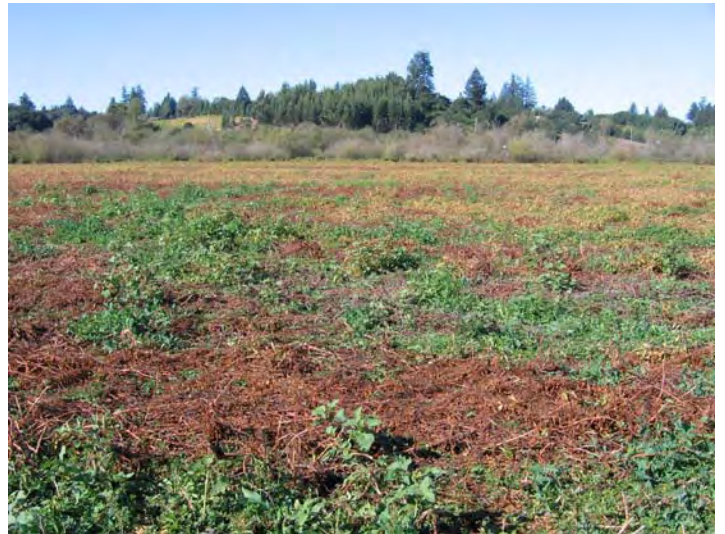
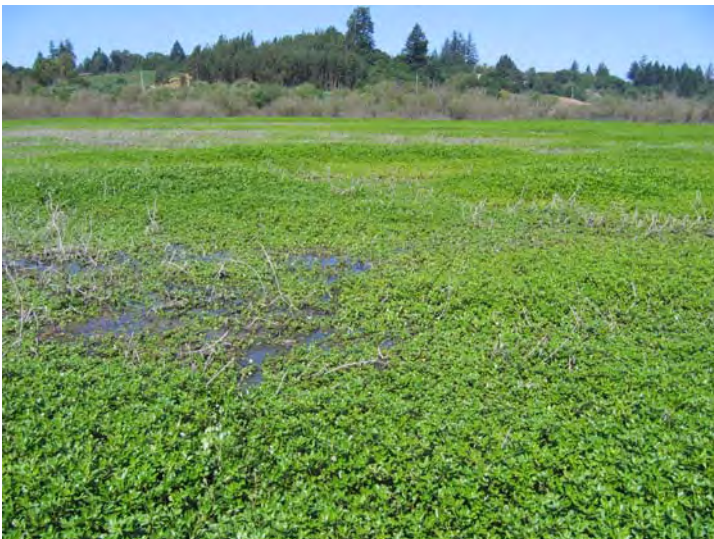
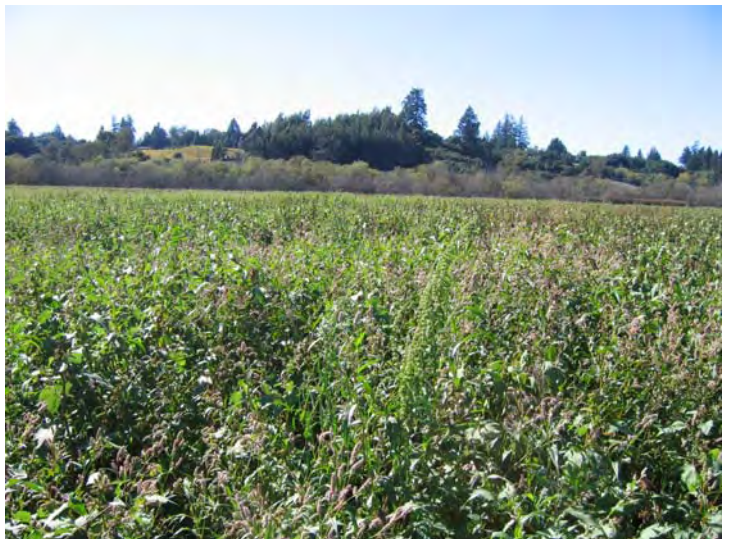
South field, flooded wetlands in Laguna Wildlife Area. Significant regrowth in June 2006 was sprayed with triclopyr. No biomass could be removed. By October 2006 the canopy cover was almost exclusively curly dock (*Rumex crispus*) and swamp knotweed (*Polygonum amphibium* var. *emersum*).

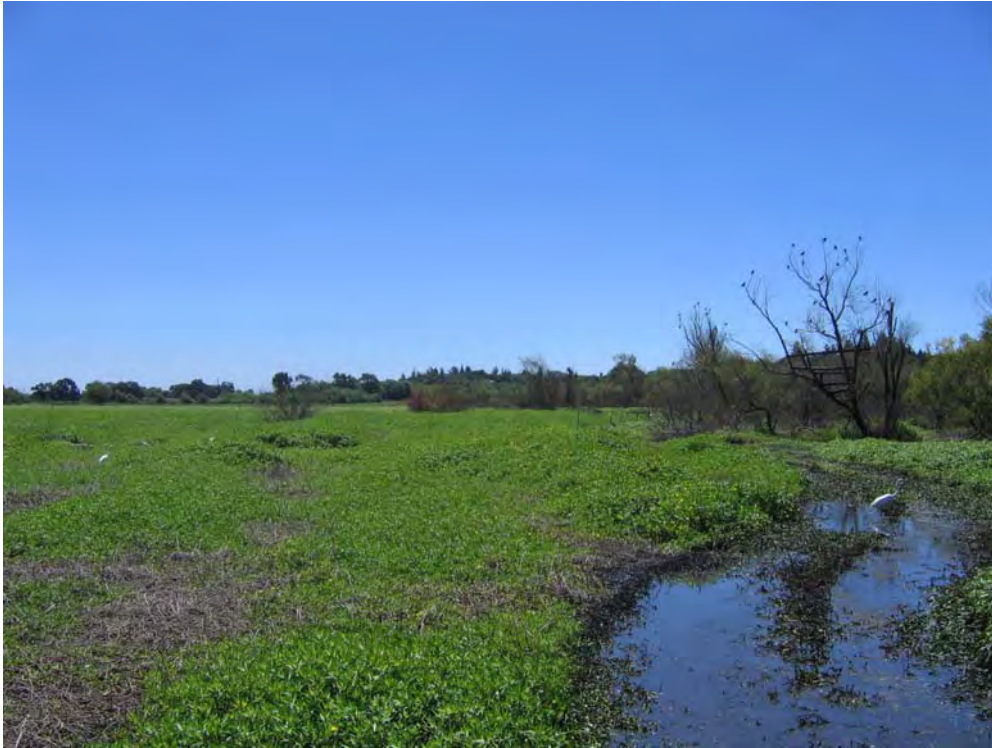
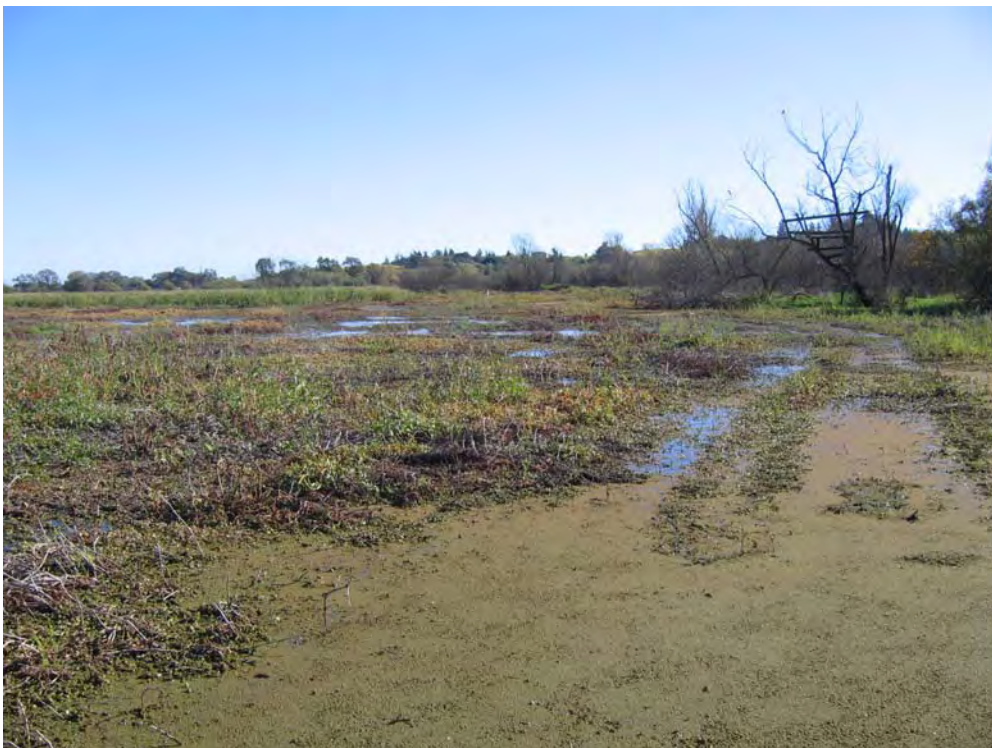
**Figure A8. CDFG Laguna Wildlife Area: Photo Point T-54**

South field, flooded wetlands in Laguna Wildlife Area (new photo point in 2006). Significant regrowth in June 2006 was sprayed with triclopyr. It is unclear from these pictures whether the *Ludwigia* has died. The water depth may prevent species other than water fern (*Azolla filliculoides*) from colonizing.

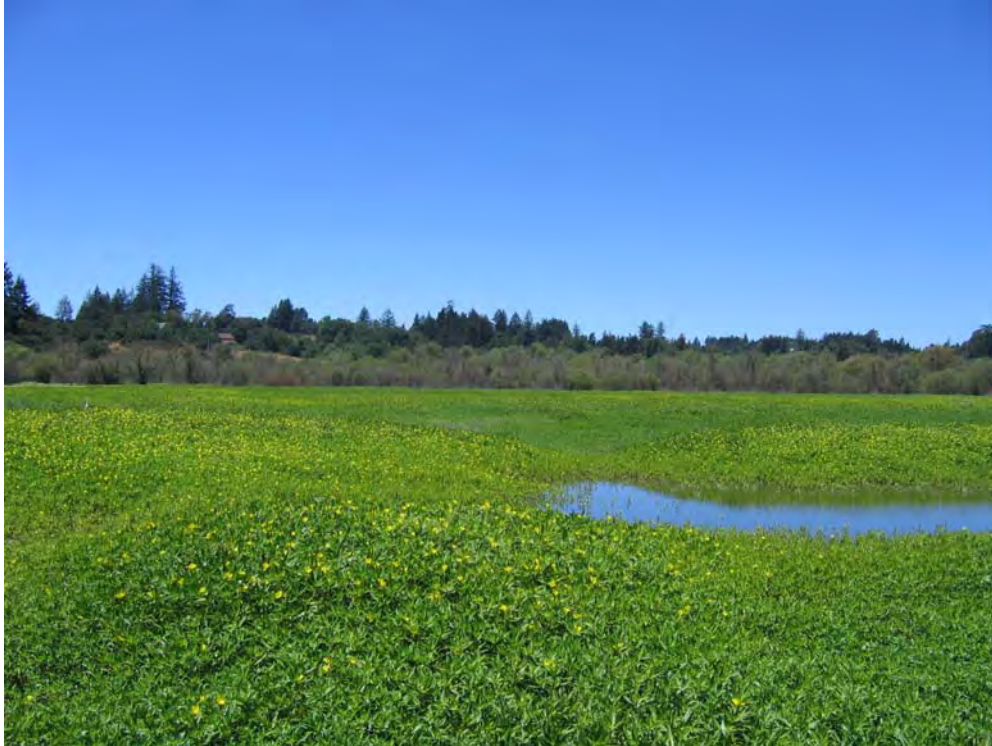
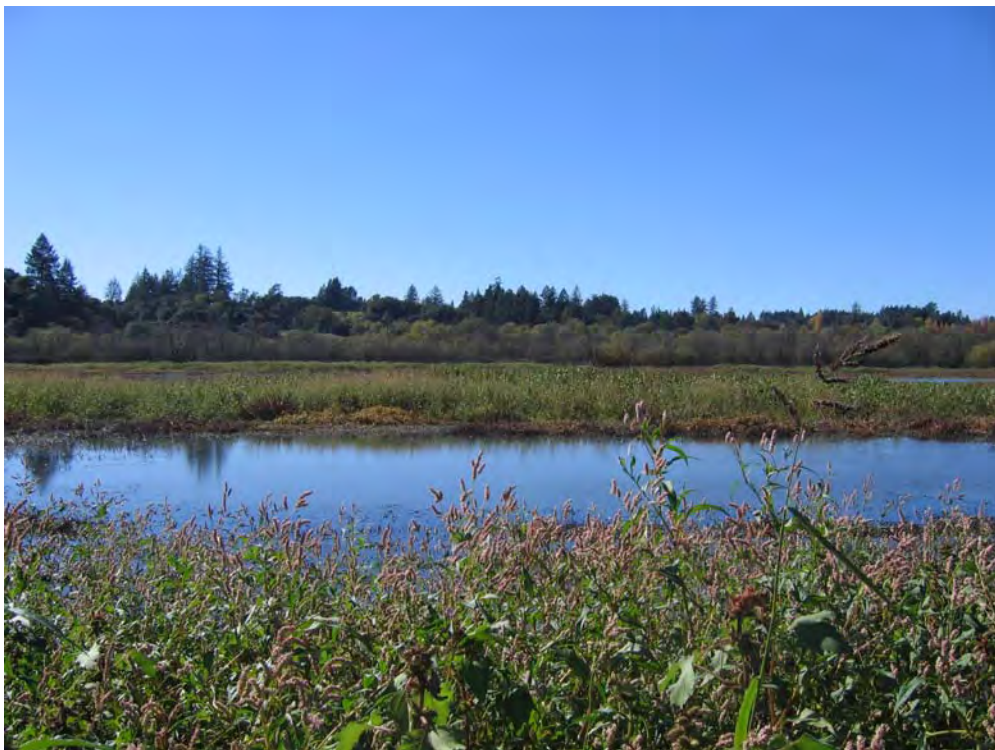
**Figure A9. CDFG Laguna Wildlife Area: Photo Point W-59**

South field, flooded wetlands in Laguna Wildlife Area (new photo point in 2006). Significant regrowth in June 2006 was sprayed with triclopyr. Canopy dominated by swamp knotweed (*Polygonum amphibium* var. *emersum*) and cocklebur (*Xanthium strumarium*).

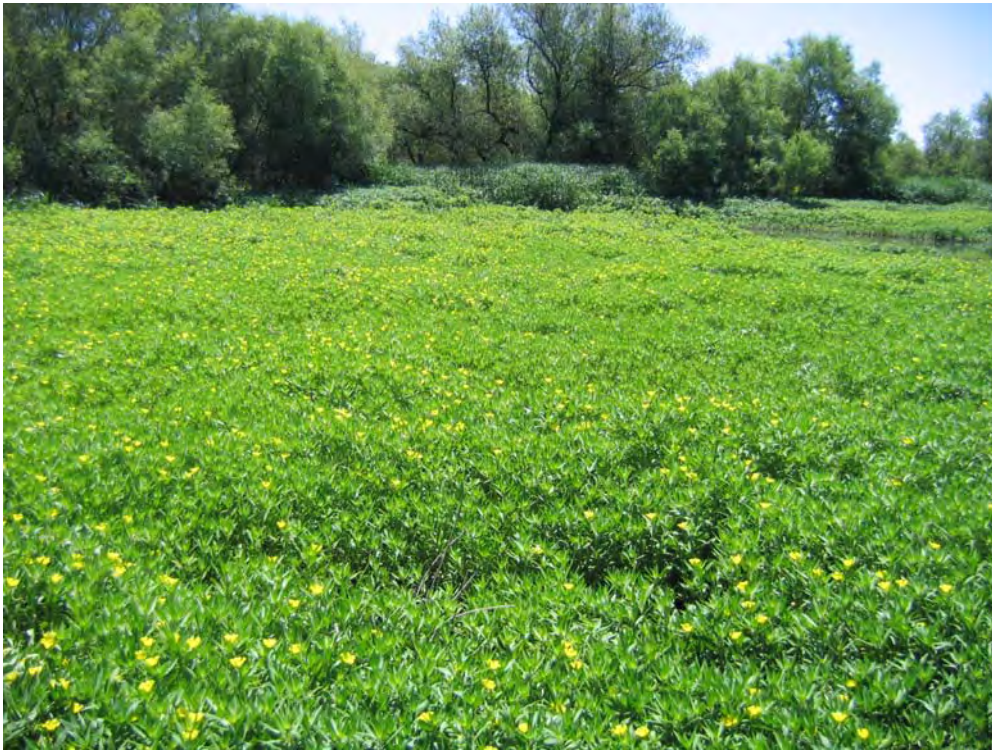
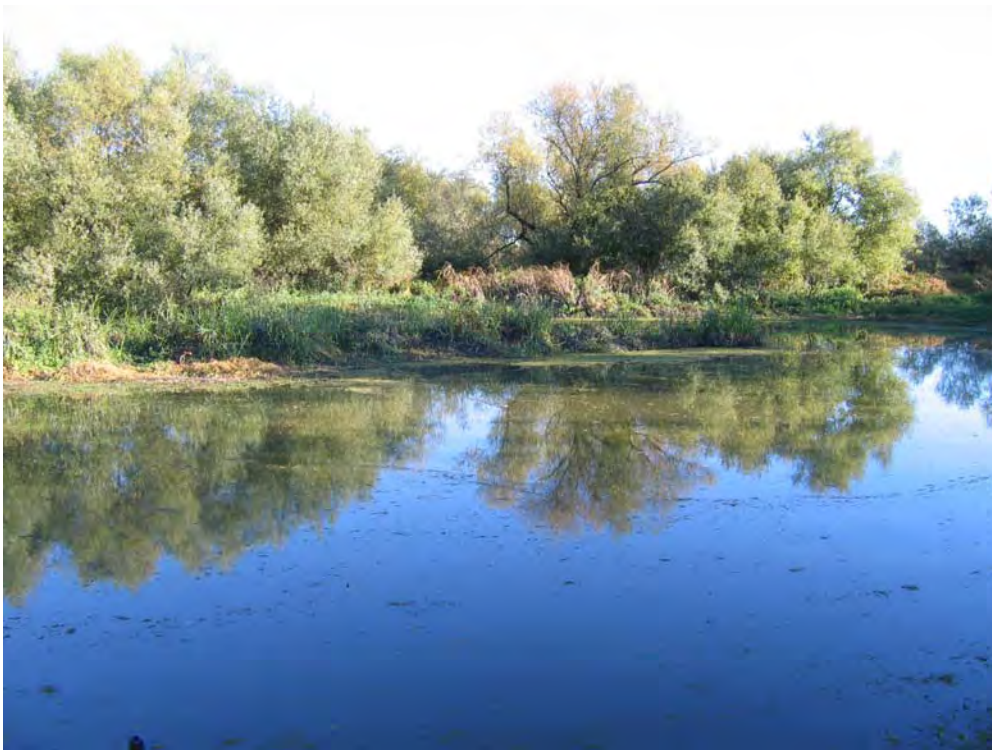
**Figure A10. CDFG Laguna Wildlife Area: Photo Point Z-63**

South field, flooded wetlands in Laguna Wildlife Area (new photo point in 2006). Significant regrowth in June 2006 was sprayed with triclopyr. Canopy dominated by swamp knotweed (*Polygonum amphibium* var. *emersum*) and cocklebur (*Xanthium strumarium*).

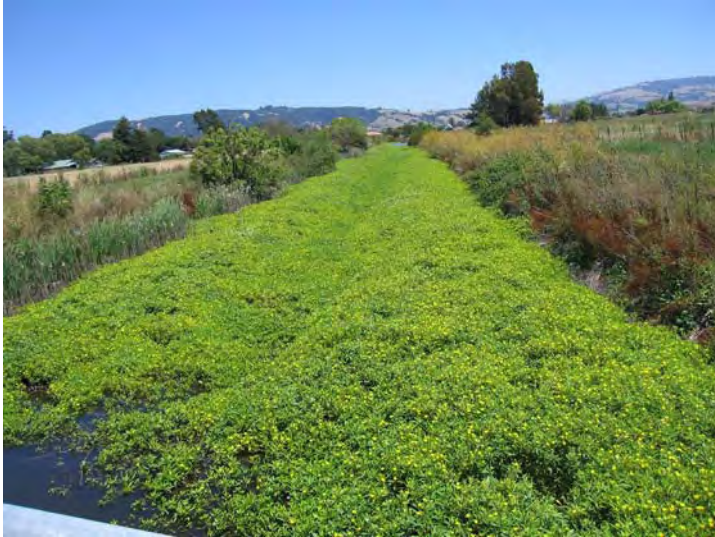
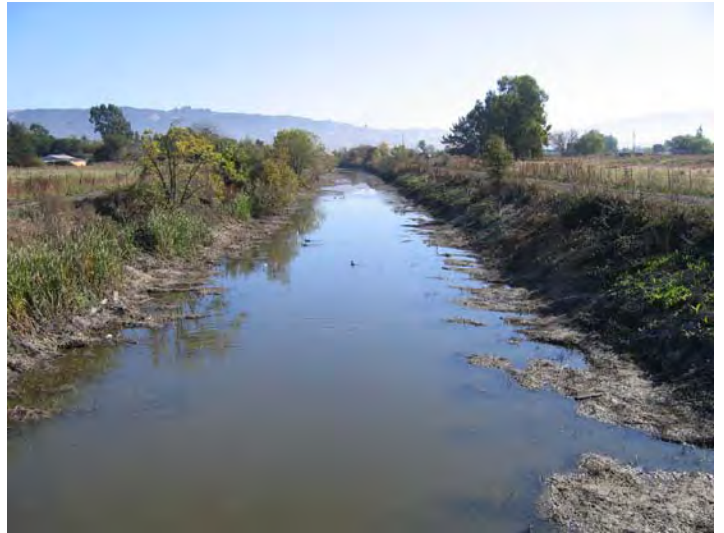
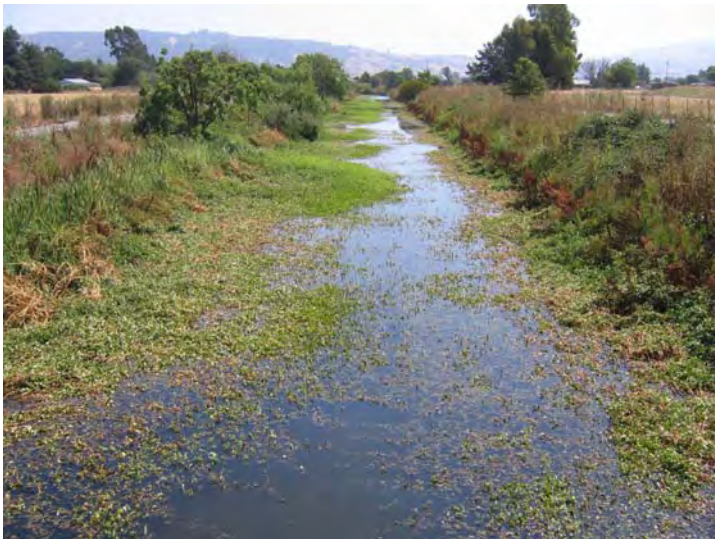
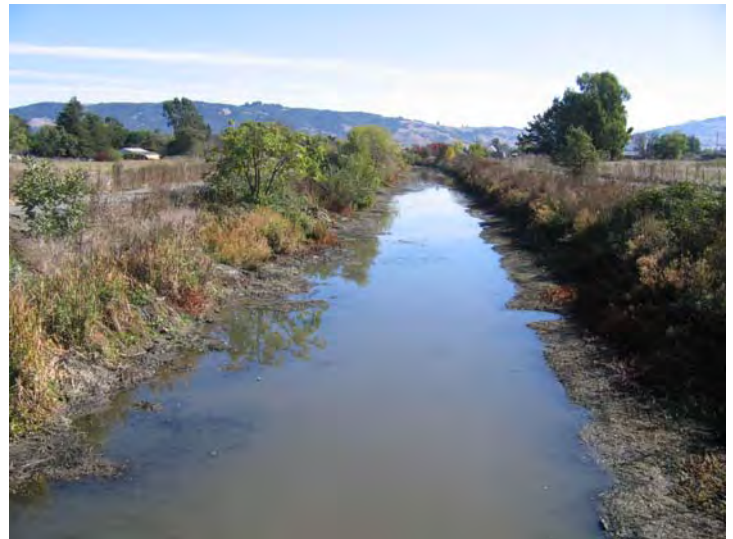
**Figure A11. SCWA Channels: Photo Point B-02**

Bellevue Wilfred channel looking northeast off the Whistler Bridge. The 2006 pre-spray picture file was corrupted so the post glyphosate spray picture is shown. Significant regrowth occurred in 2006. Note the amount of water in the channel at the end of each season despite no precipitation for months. Water is likely from urban uses such as irrigation, car washing, etc.

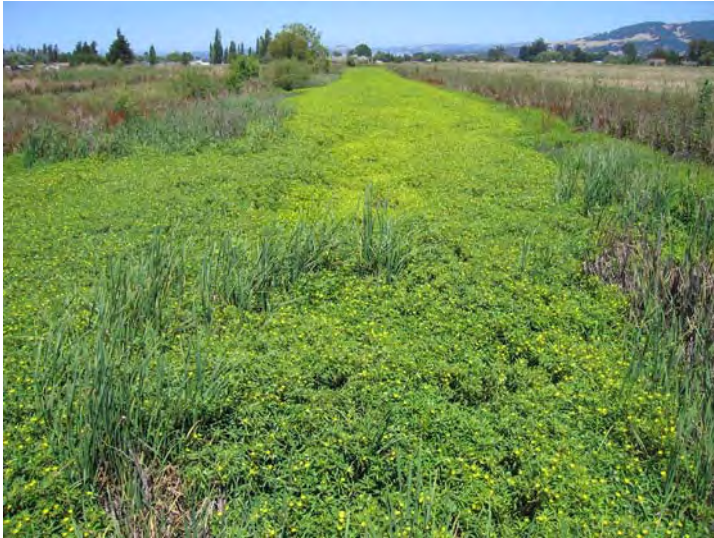
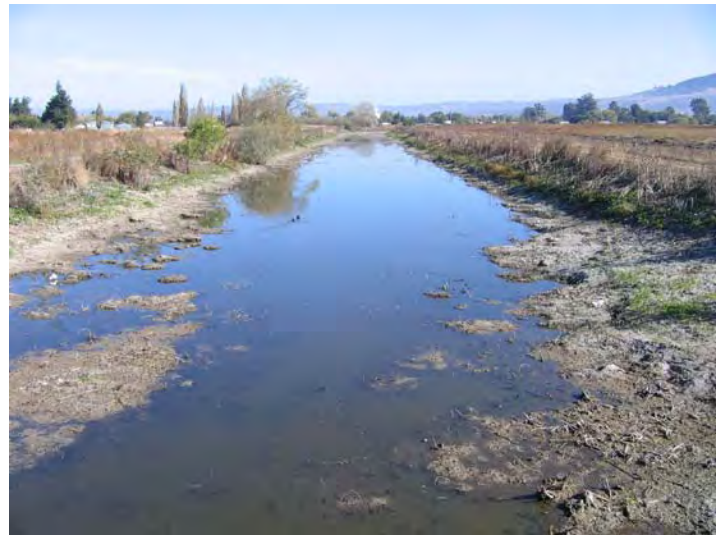
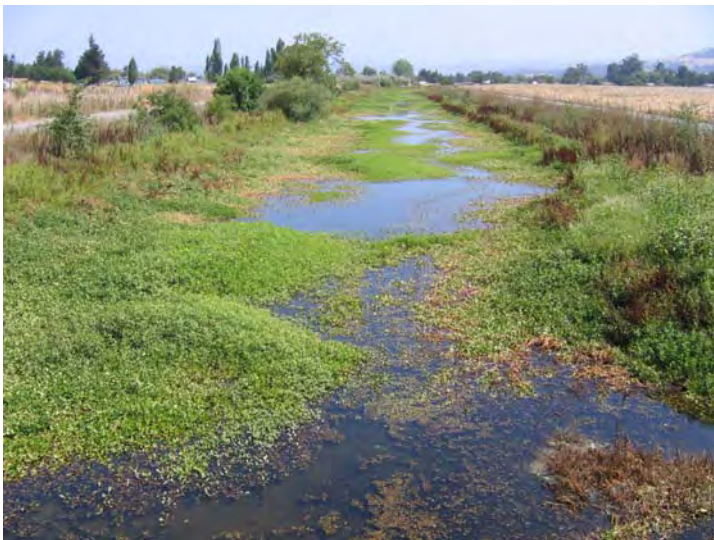
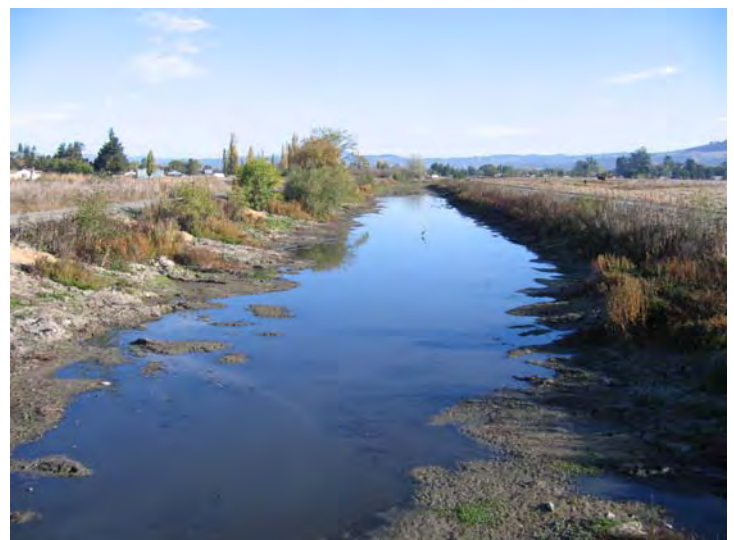
**Figure A12. SCWA Channels: Photo Point C-04**

Bellevue Wilfred channel looking north off the Wilfred Bridge. The 2006 pre-spray picture file was corrupted so the post glyphosate spray picture is shown. The amount of regrowth is still evident after the spraying. The channels were clear again after removal.
