# Ludwigia Control Project

## Year Two Report

February 2007

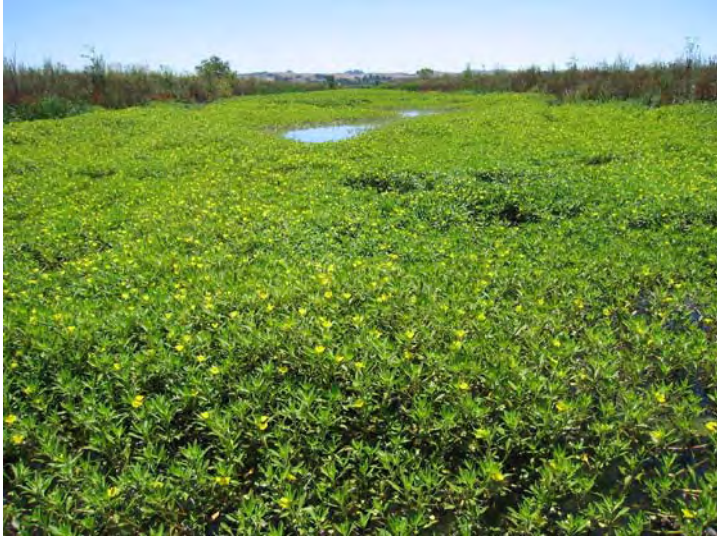
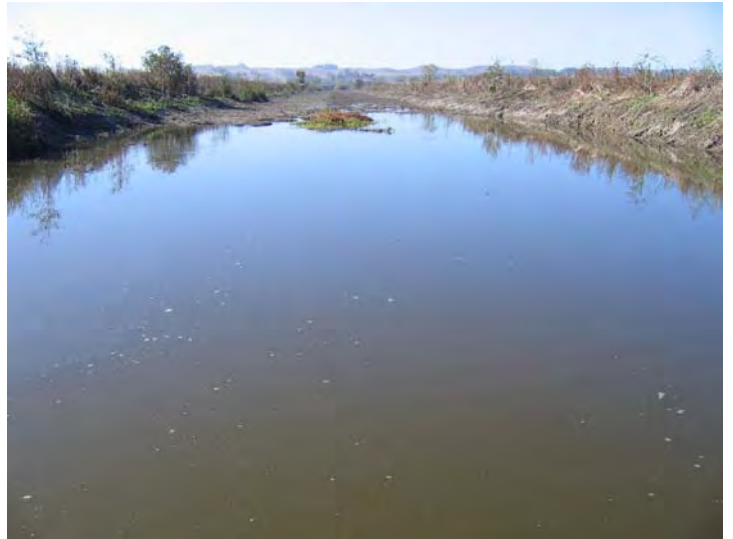
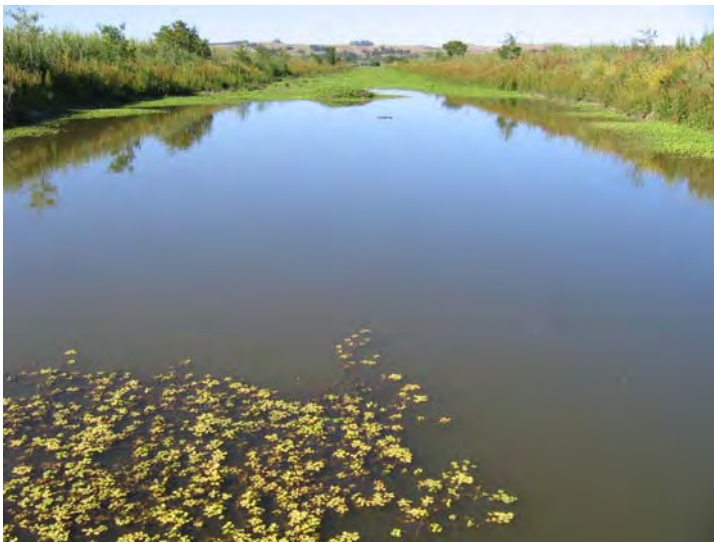
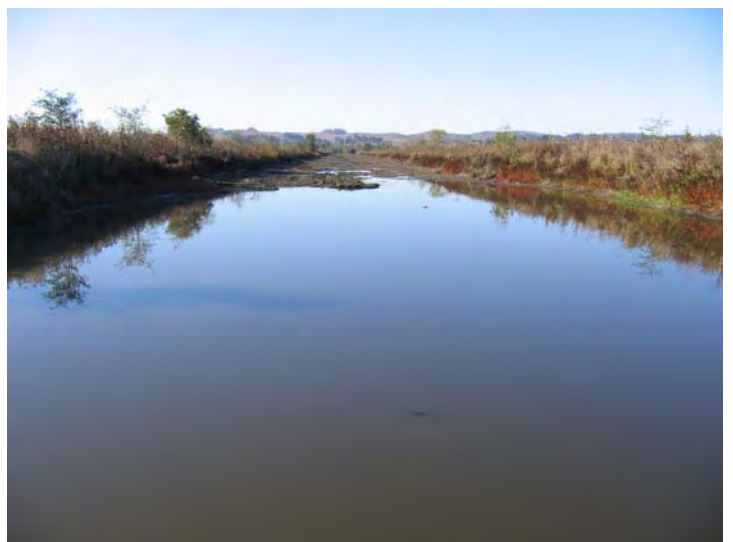
**Figure A13. SCWA Channels: Photo Point D-07**

Bellevue Wilfred channel looking north toward the Wilfred Bridge. The deeper water in the foreground appears to have limited regrowth while significant growth is visible in the background.

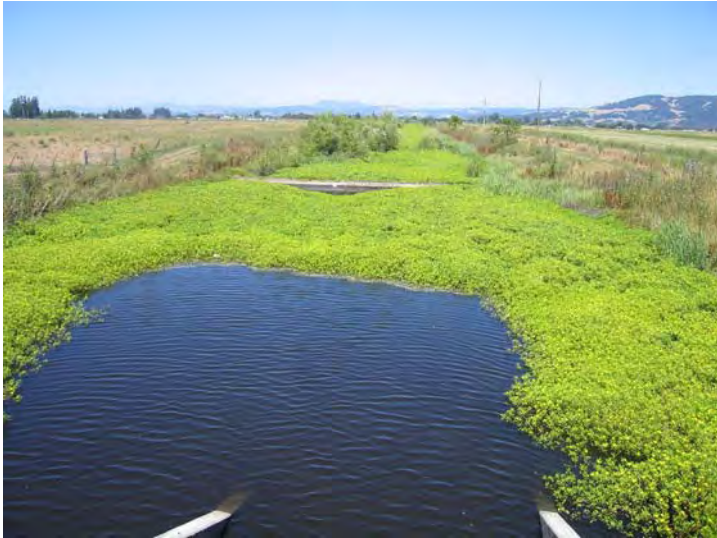
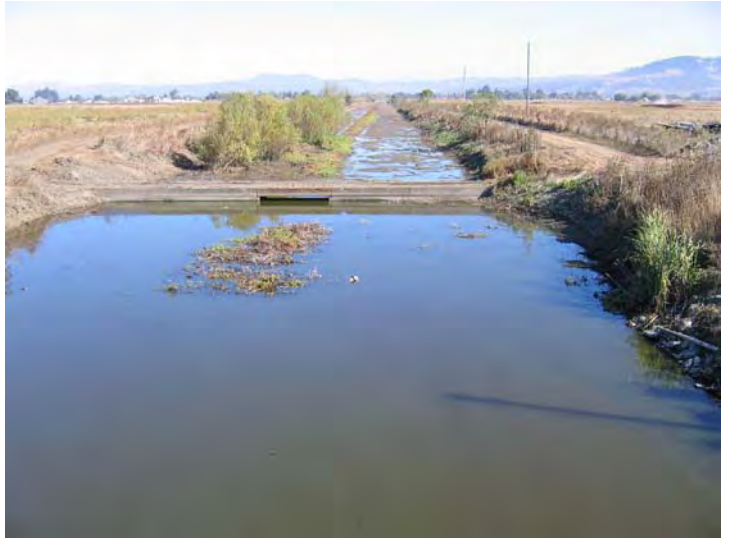
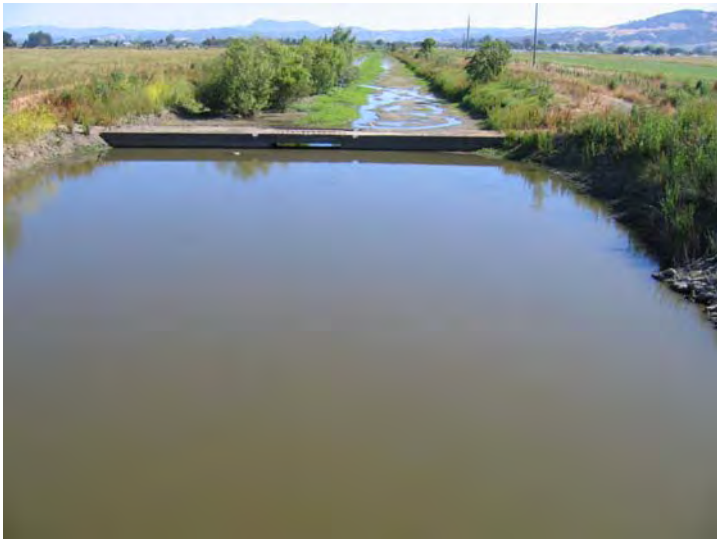
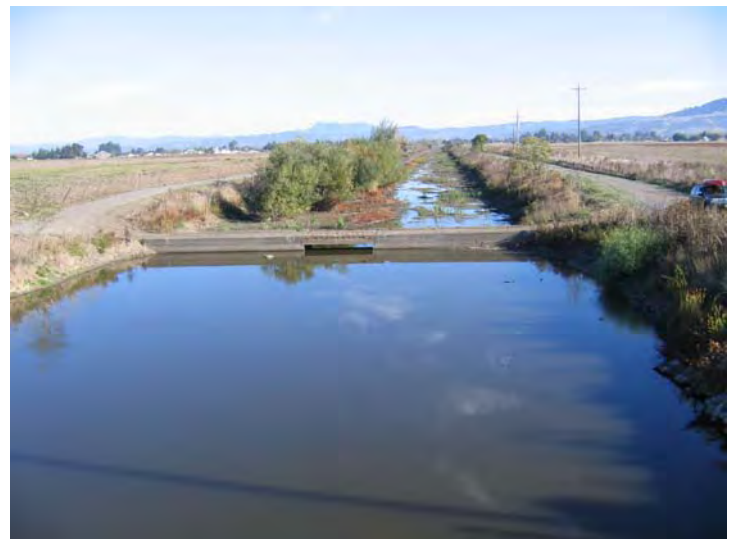
**Figure A14. SCWA Channels: Photo Point F-10**

Bellevue Wilfred channel looking north from Rohnert Park Expressway. Again, it appears that the deep water in the foreground prevented regrowth. On the far side of the cross bridge regrowth was heavier and continued even after the glyphosate application.

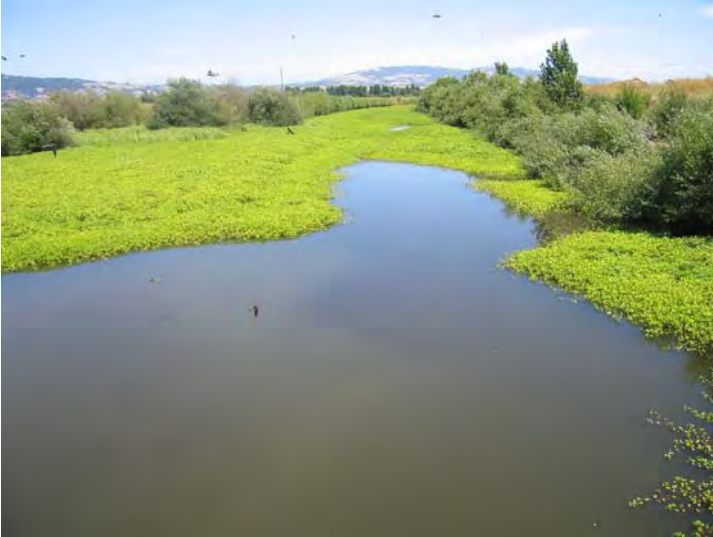
**Figure A15. SCWA Channels: Photo Point H-12**

Pre-spray  
July 2005

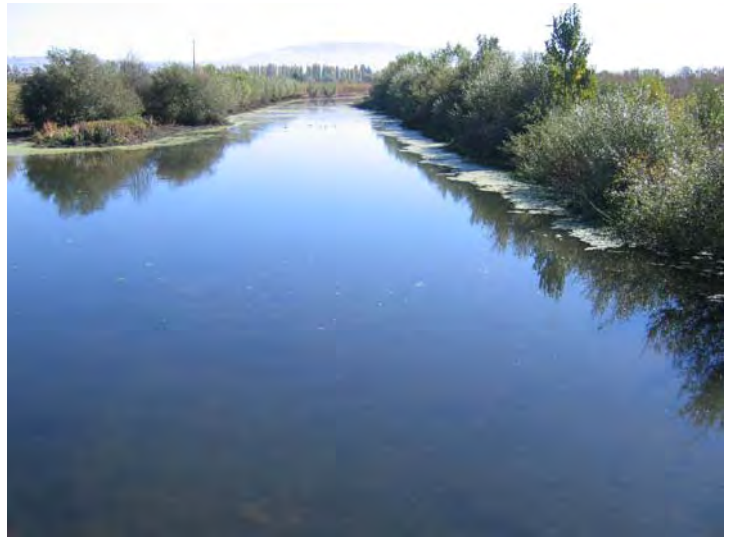
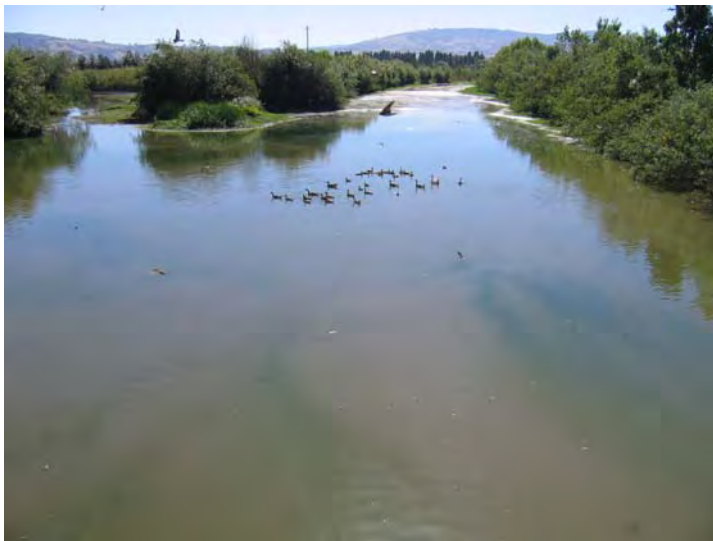
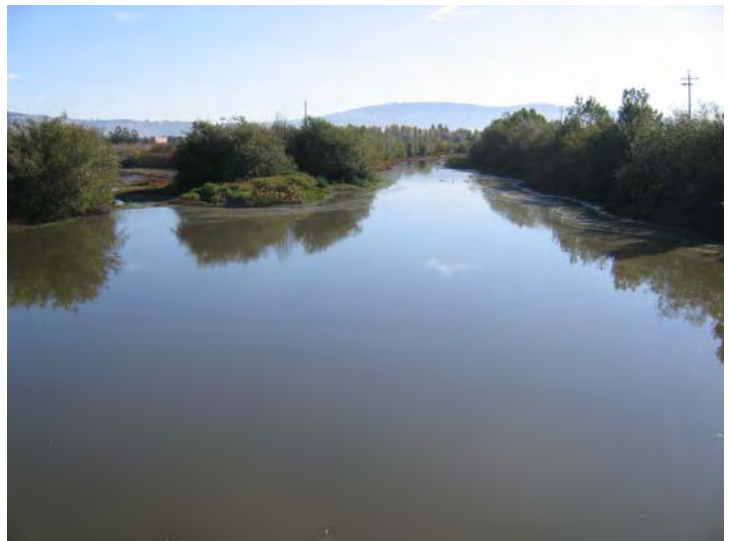
Main Laguna channel looking east from Stony Point Road Bridge. Limited regrowth by June 2006. However, regrowth was heavier after the glyphosate application. Following the triclopyr application the growth was again controlled. No mechanical removal took place in the main channel.

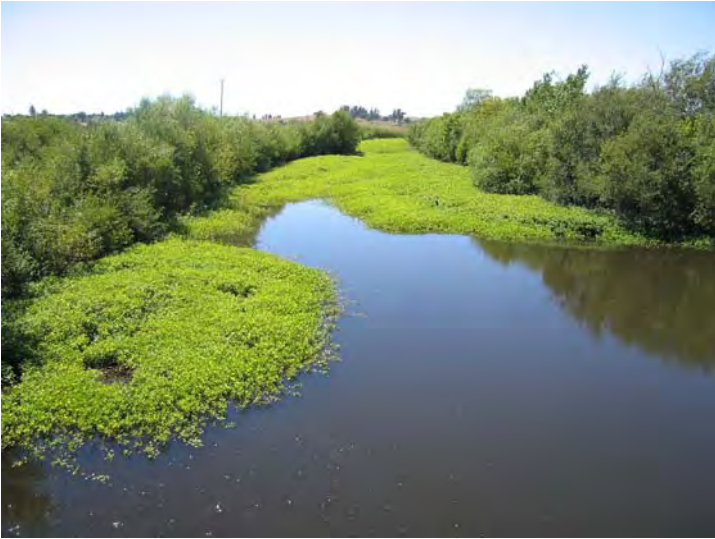
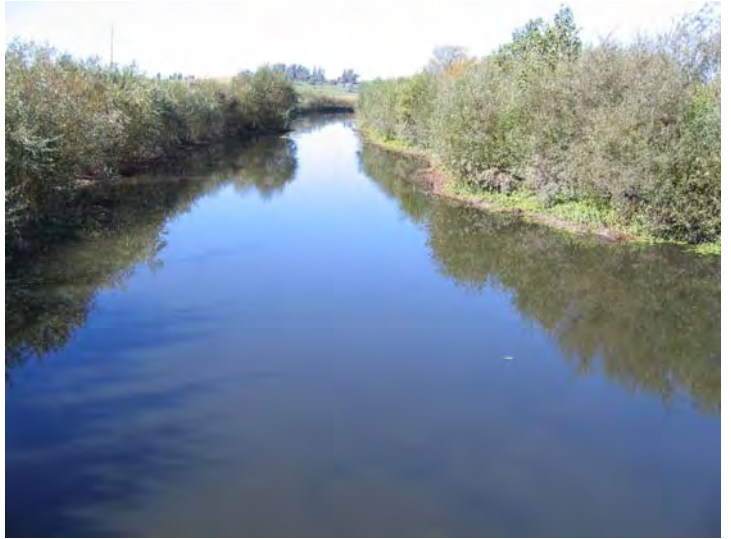
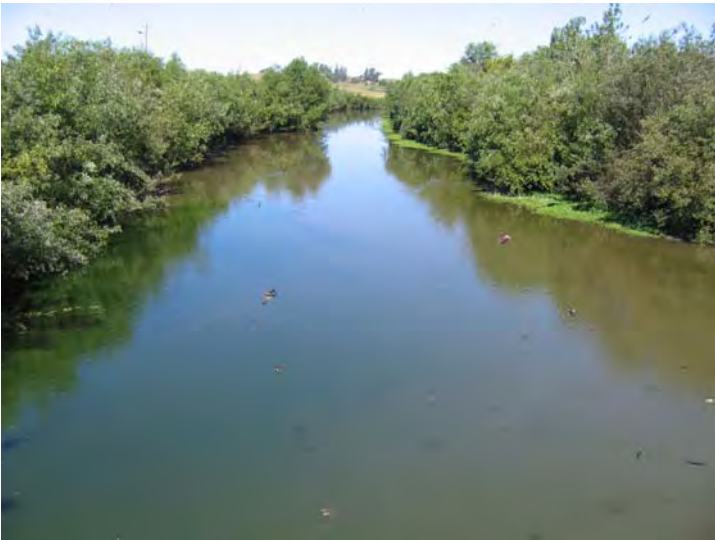
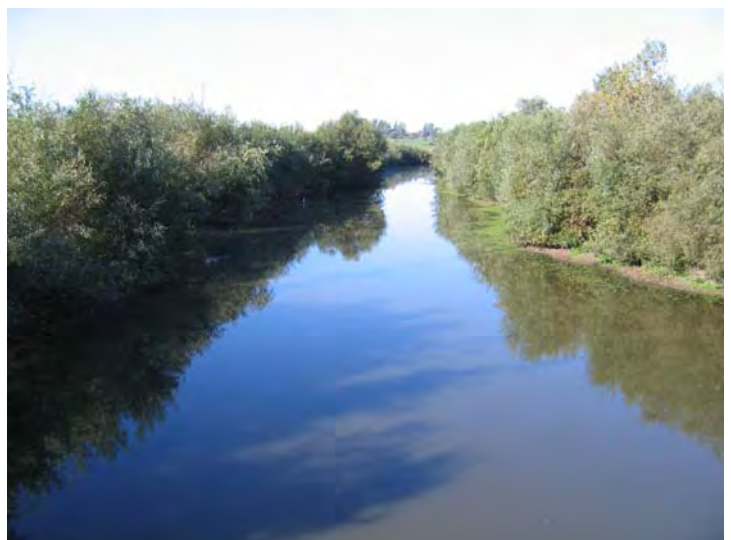
**Figure A16. SCWA Channels: Photo Point I-13**

Main Laguna channel looking west from the north side of the Stony Point Road Bridge. Limited regrowth occurred in this relatively deep channel. No mechanical removal was required.

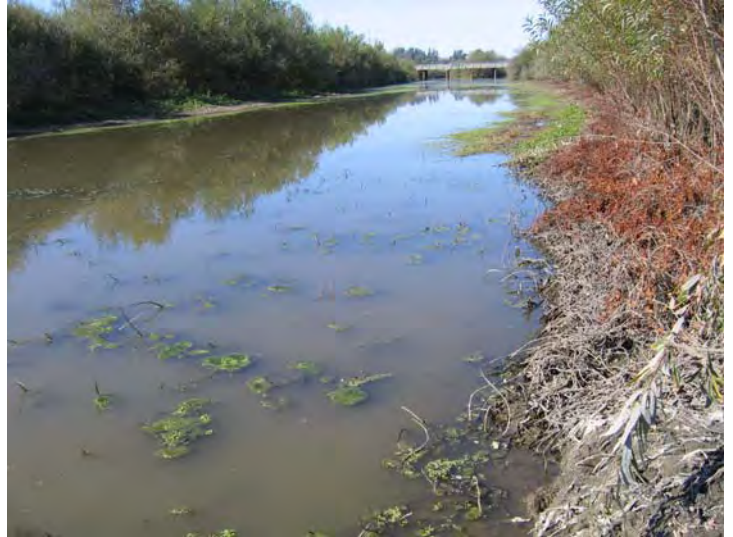
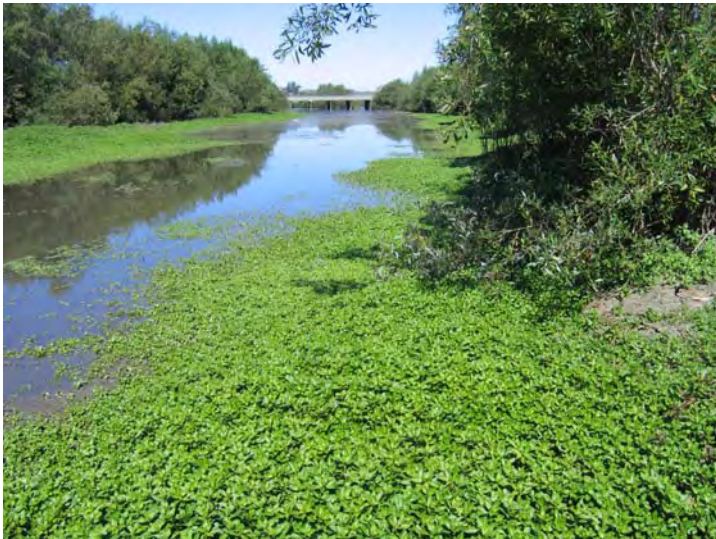
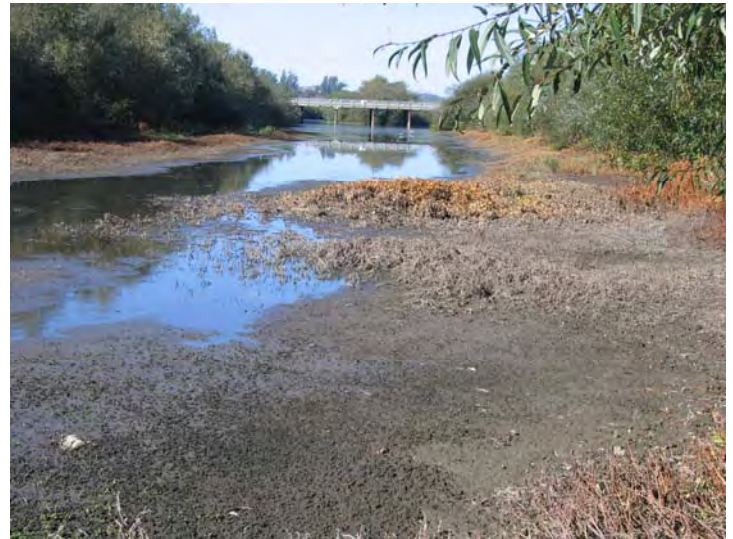
**Figure A17. SCWA Channels: Photo Point O-23**

Main Laguna channel looking west toward the Stony Point Road Bridge. Significant regrowth occurred in the shallow portions of the channel. Triclopyr provided excellent control in this section.
